# **A Glossary of Historic Masonry Deterioration Problems and Preservation Treatments**

Compiled by Anne E. Grimmer

Department of the Interior  
National Park Service  
Preservation Assistance Division

1984

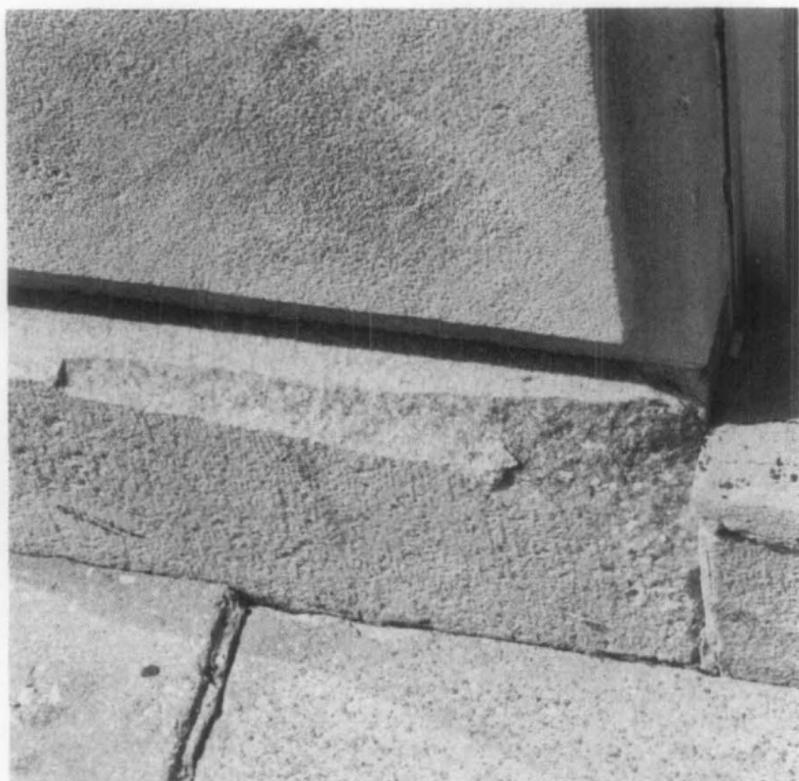
Small pieces or larger fragments of masonry separating from the masonry unit, often at corners or mortar joints. This may be the result of damage caused by later alterations or repairs, such as use of too hard a mortar, or by accident or through vandalism.

*Chipping of granite sill. Photograph: Anne E. Grimmer.*

*Preservation Treatment:* See Dutchman Repair, p.56; Replacement/Patching with Like or Compatible Substitute Materials, p.59.

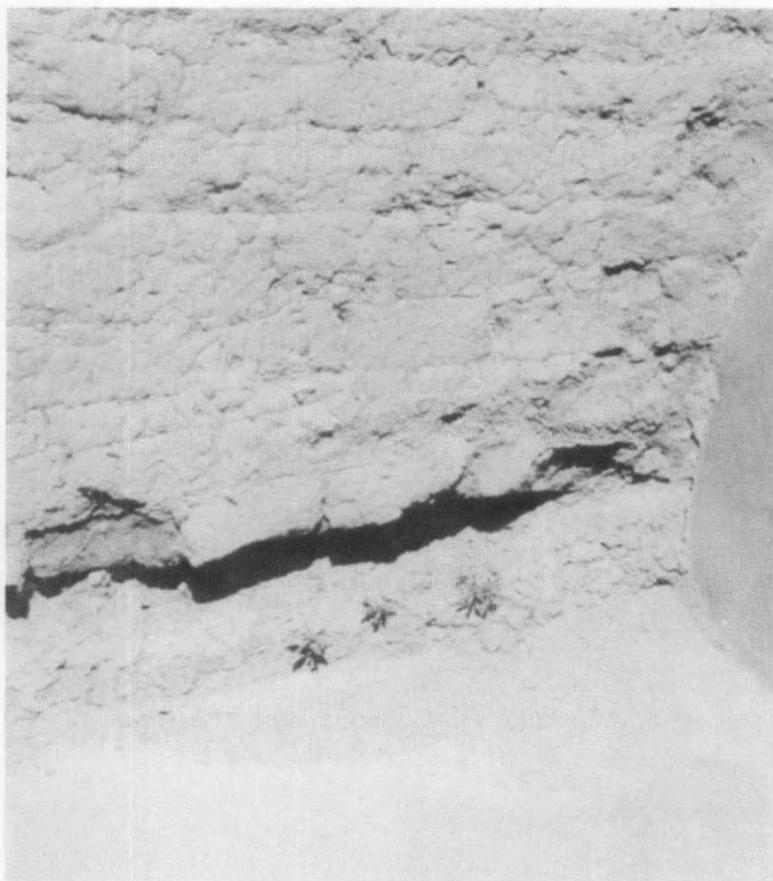
The hollowing out of an adobe wall just above grade level. Coving may be caused by standing rainwater or rainwater splash off the ground. It can also be caused by salts deposited in the adobe by the evaporation of water.

*Coving of adobe wall. Photograph: National Park Service.*

*Preservation Treatment:* See Replacement/Patching with Like or Compatible Substitute Materials, p.59.

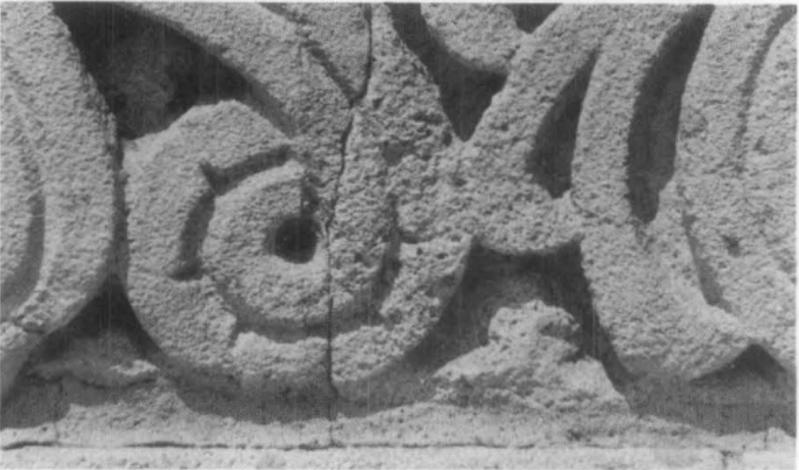
A term describing narrow fissures from 1/16 to 1/2 inch wide in a block of masonry. Cracking may result from a variety of conditions, such as structural settlement of a building, too hard a repointing mortar, or it may be an inherent characteristic of the masonry itself, such as unfired brick or adobe. Small cracks within a single block of masonry may not be serious, but longer and wider cracks extending over a larger area may be indicative of structural problems, and should be monitored.

*Cracking of limestone. Photograph: John H. Myers.*

*Preservation Treatment:* See Mechanical Repair, p.58; Replacement/Patching with Like or Compatible Substitute Materials, p.59.

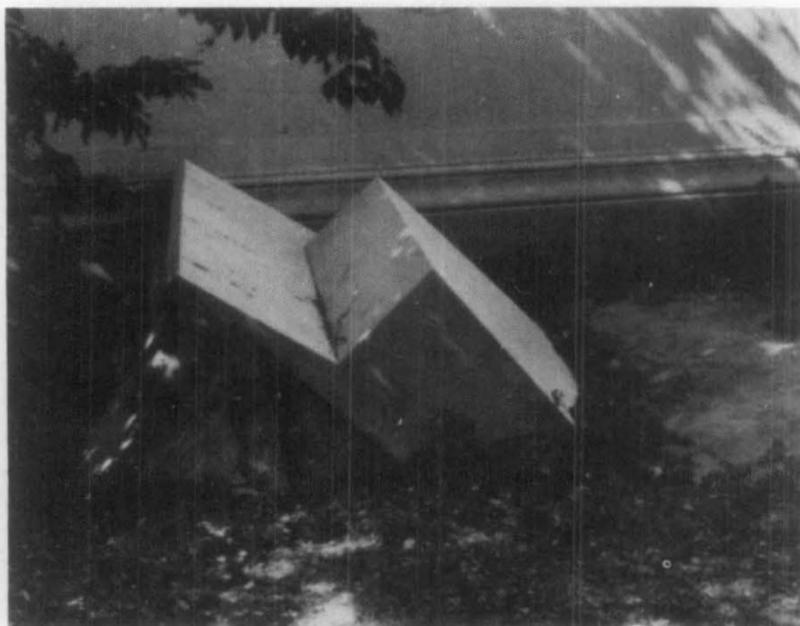
*Section of marble lying on the ground at base of building after it had separated from pediment above. Photograph: Walter Smalling.*

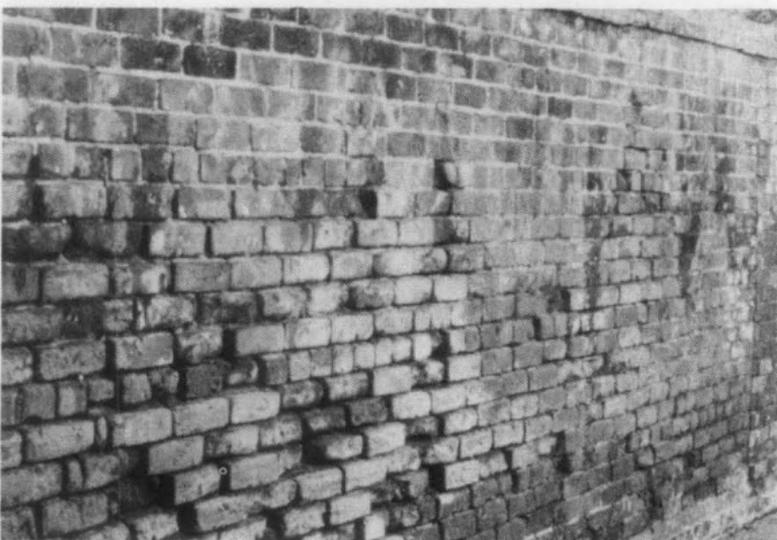
A whitish haze of soluble salts on masonry generally caused by excessive "pulling" of soluble salts into the masonry and out through the surface. Capillary action may pull soluble salts which result in efflorescence from the ground into the masonry, such as chlorides from salting of streets and sidewalks in winter and nitrates from fertilizers. In addition, carbonates from lime mortar and air-borne or water-deposited pollutants in the atmosphere may cause sulfates to be deposited on the surface of the masonry. Sulfates resulting from the curing and firing process are a common source of efflorescence in brick. Finally, efflorescence may be a combined salt residue left on the masonry surface by chemical cleaning, too strong a chemical solution, or improper rinsing.

Efflorescence itself may be more unsightly than harmful, but its presence on an older or historic masonry building often serves as a warning, indicating that water has found a point of entry into the structure. Once this has occurred, more serious damage can usually be predicted. Efflorescence may also indicate salt accumulations under the surface of the masonry (subflorescence) which are potentially damaging to the masonry, and are most definitely a matter of concern.

*Efflorescence and spalling on brick wall. Photograph: Anne E. Grimmer.*

*Preservation Treatment:* See Poulticing, p.44; Water Washing, p.46.

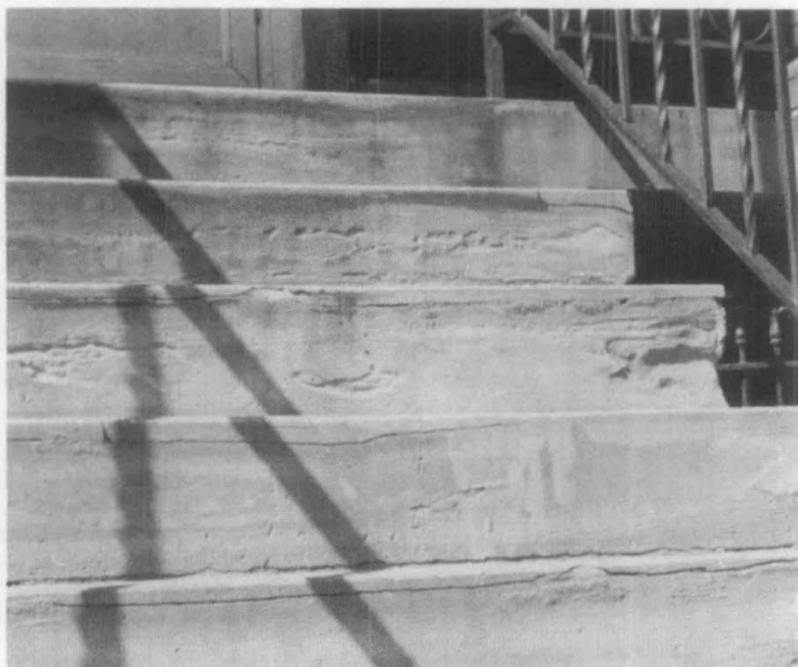
Wearing away of the surface, edges, corners or carved details of masonry slowly and usually by the natural action of wind or windblown particles and water. Erosion is one of the most serious kinds of adobe deterioration.

*Differential erosion of sandstone steps follows bedding planes of greater and lesser resistance. Photograph: Anne E. Grimmer.*

*Preservation Treatment:* See Replacement/Patching with Like or Compatible Substitute Materials, p.59.

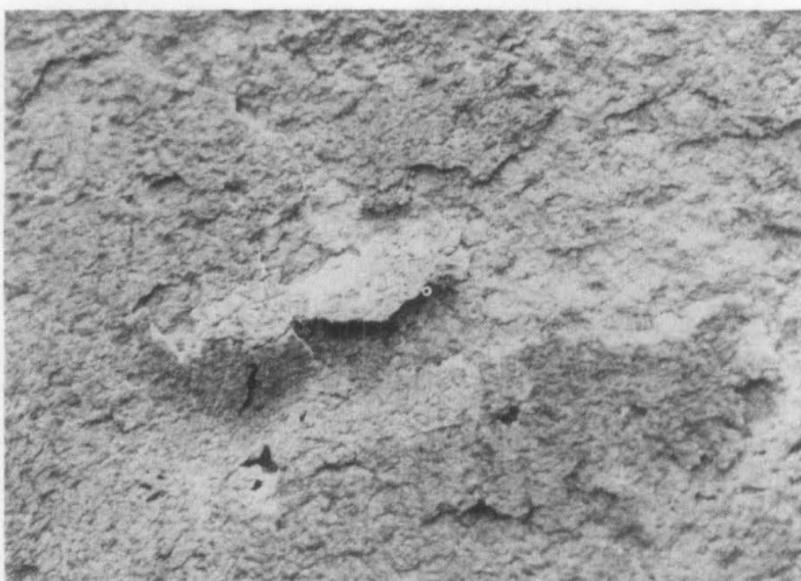
Flaking is an early stage of peeling, exfoliation, delamination or spalling, and is best explained as the detachment of small, flat, thin pieces of the outer layers of stone from a larger piece of building stone. Flaking is usually caused by capillary moisture or freeze-thaw cycles that occur within the masonry. The application of a water-repellent coating may result in flaking of the masonry when trapped moisture is forced to the surface.

*Flaking of granite. Photograph: Baird M. Smith, AIA.*

*Preservation Treatment:* To date, no completely effective treatment has been developed for this condition.

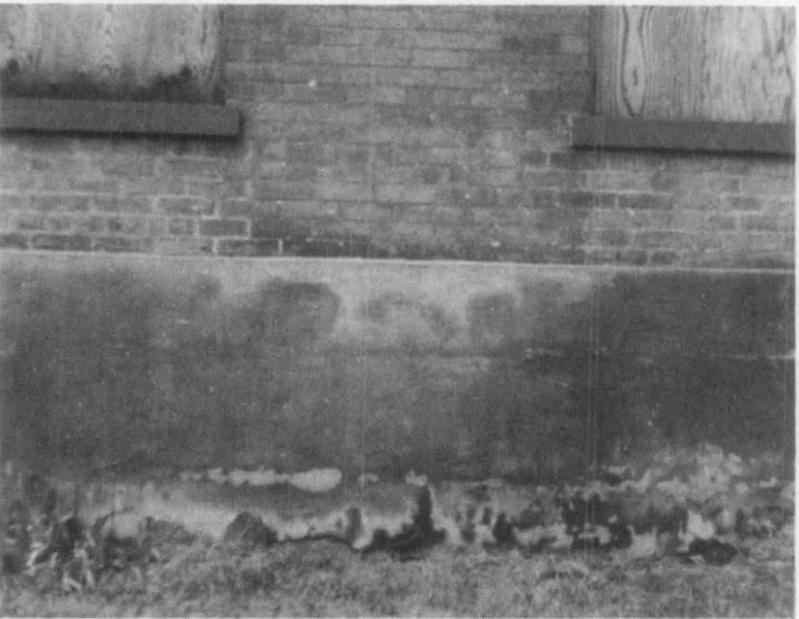
The suction of groundwater into the base of masonry walls through capillary action is called rising damp. Moisture is drawn up into the building walls and released at the interior and exterior surfaces where a horizontal wet stain or tidemark is left. The moisture often carries with it salts in solution, which can result in efflorescence and lead to deterioration of masonry, plaster, wood and paint. Rising damp, often the result of improper drainage, is a problem common to many older masonry structures, and one that is difficult to solve completely.

*Rising damp evidenced on parged foundation.  
Photograph: John Stubbs.*

*Preservation Treatment:* See Dampproof Course, p.54.

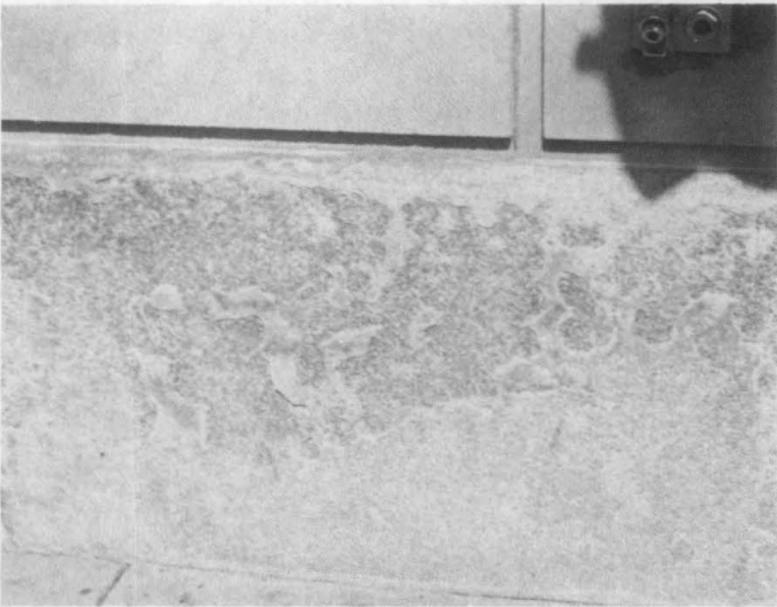
Sometimes called salt erosion, this condition results in an obvious pattern of erosion or etching of the stones caused by salt, usually from the salting of icy sidewalks. Unless the use of de-icing salts is discontinued, this condition can eventually result in spalling and exfoliation of the stone surface.

*Salt fretting on granite base probably resulting from use of de-icing salts on sidewalk. Photograph: Anne E. Grimmer.*

*Preservation Treatment:* To date, no completely effective treatment has been developed for this condition.

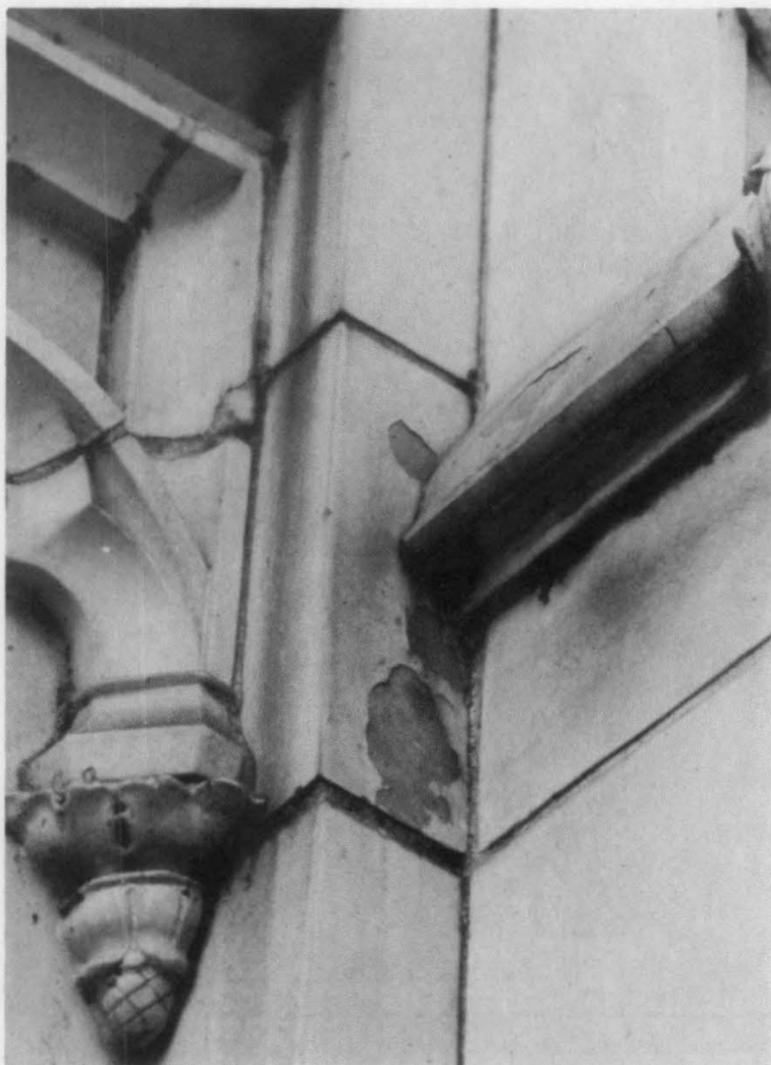
Spalling of terra cotta is of two types: glaze spalling and material spalling. Both are the result of air-borne water or water from other sources being trapped behind the glazed surface of the clay. When the water builds up in sufficient pressure to cause expansion of the clay body, the relatively impervious glaze prevents the water from escaping, and the glaze will blister or pop off from the clay surface (glaze spalling), or the clay body itself may fracture or disintegrate (material spalling). Spalling in terra cotta, as in other types of masonry, may also be caused by deterioration of the internal anchoring system which holds the units to the building structure. Water infiltration causes the metal anchors or metal reinforcement to rust which in turn creates increased internal pressure in the masonry units or concrete, resulting in spalling, and potential failure of the structural system if the anchoring fails completely.

*Glaze spalling of glazed terra cotta. Photograph: John H. Myers.*

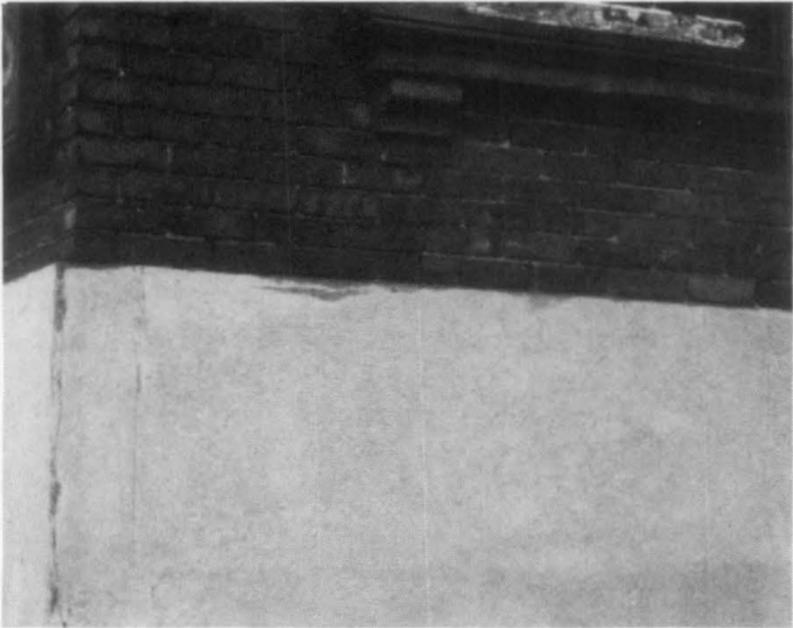
In masonry construction, a thin coat of cement mortar (often containing dampproofing ingredients) applied to provide a smooth surface for rough masonry, or as a dampproofing measure for rough masonry, foundation and basement walls. In Great Britain, parging or pargeting describes the traditional decorative plastering of the exterior, including timbers, with a tough lime plaster reinforced with ox-hair and decorated with impressions or patterns made with a mold or comb.

*Parging over brick. Photograph: National Park Service.*

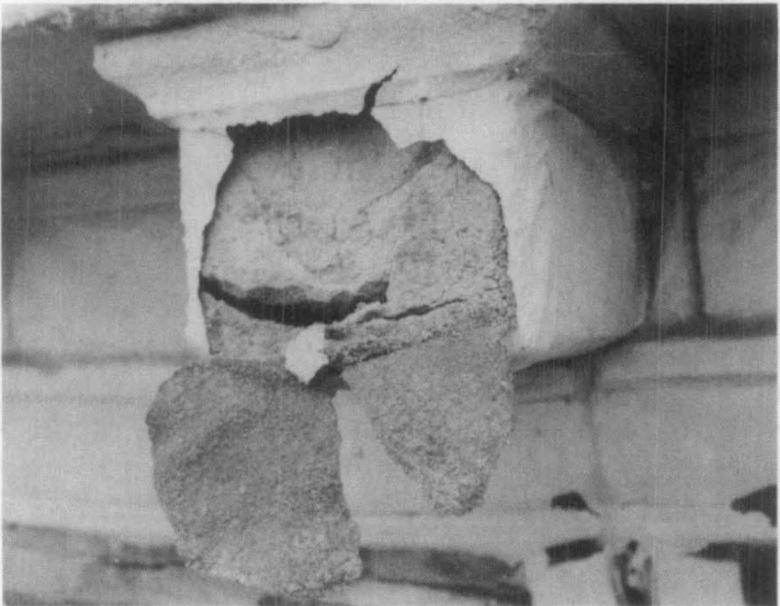
These coatings seal the masonry surface from both liquid water and water vapor; they may be clear or opaque—and include bituminous coatings such as those applied to building foundations, and also some paints. They generally do not cause problems as long as they exclude all water from masonry, but if water does enter the wall, the coating can intensify the damage to the wall because the water will not be able to escape. Basically, waterproof coatings make a surface *impervious* to water.

*A neoprene coating over a limestone cornice has trapped water (which entered through leaks in the parapet) inside these stone dentils. The built-up water pressure has finally forced the coating to pop off, taking with it pieces of the stone. Photograph: National Park Service.*

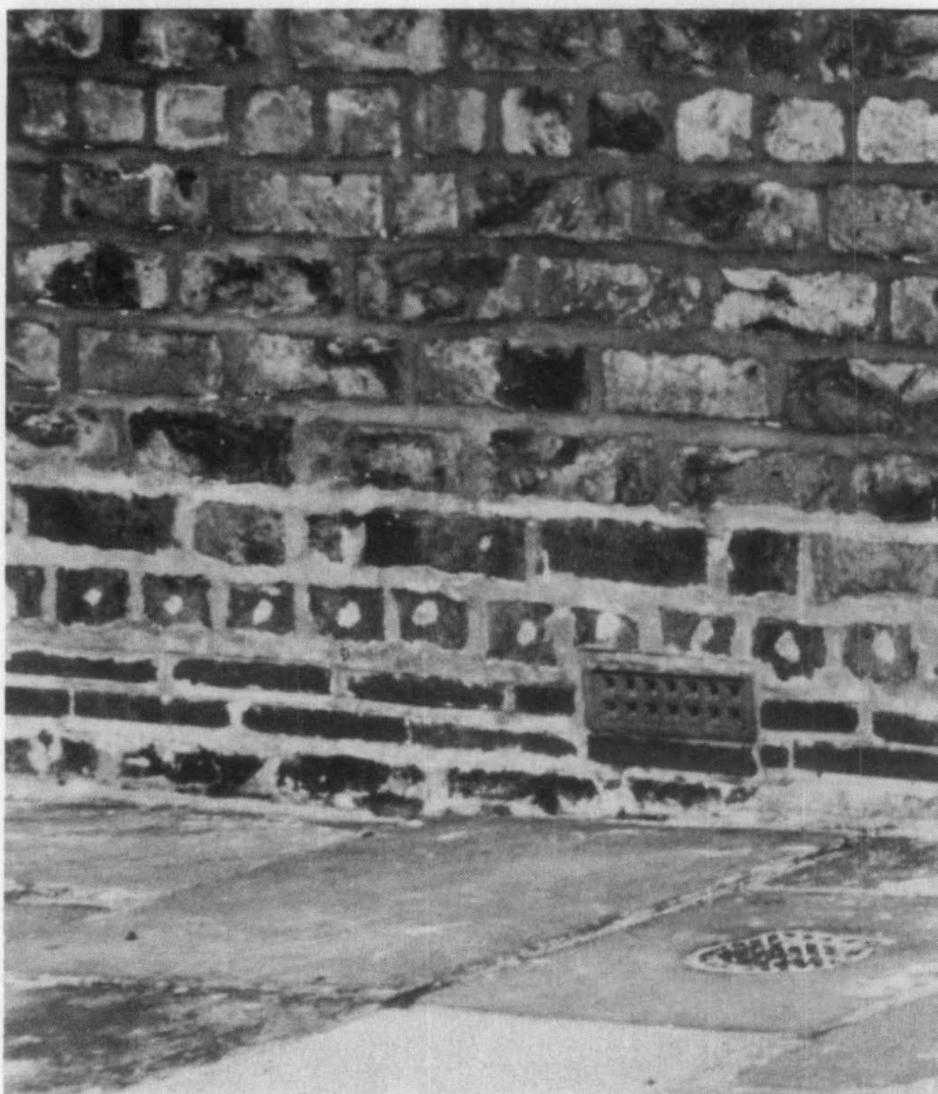
Installation in masonry of a horizontal layer of material which is impervious to water, such as tile, slate, lead-cored bituminous sheet or bituminized felt, polyethylene sheeting, or metal, to prevent the capillary rise of moisture—**rising damp**—from the ground into the masonry wall. Historically, some masonry buildings were constructed with a dampproof course, but usually dampproof courses must be added later as a remedial measure to correct problems caused by rising damp. A traditional dampproof course is not installed without difficulty, as a continuous horizontal course must be cut out of the mortar or brick at a level just above the ground and below first floor joists, and the dampproofing material inserted in an uninterrupted horizontal course. This system

*The horizontal row of white dots in the brick headers indicates that a chemical dampproof course has been injected. Photograph: Baird M. Smith, AIA.*
